COMBUSTION TURBINE (CT) HOT SECTION COATING LIFE MANAGEMENT

Semi Annual Technical Progress Report

Agreement Number: DE-FC26-01NT41231

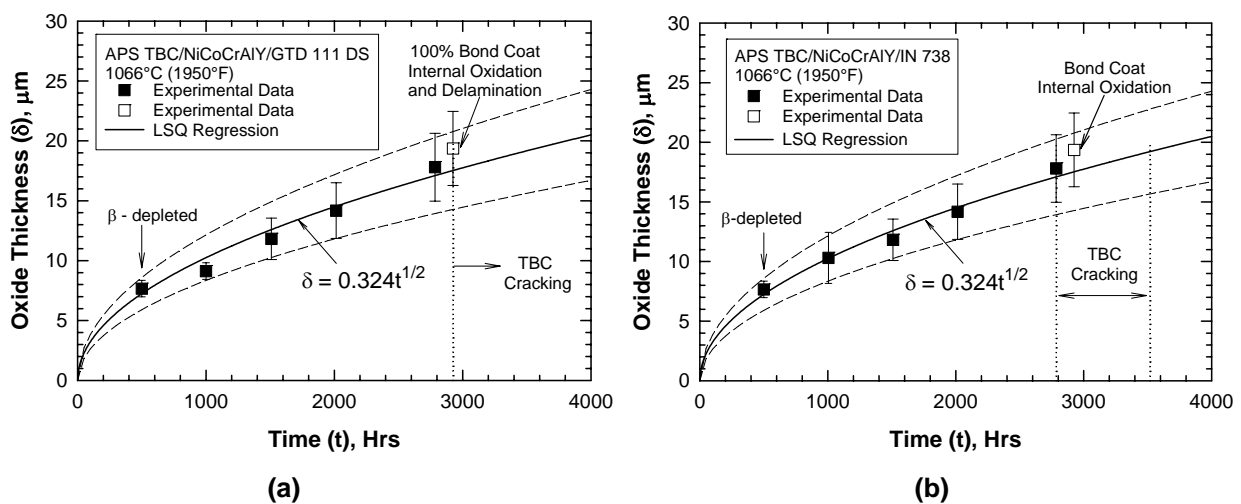
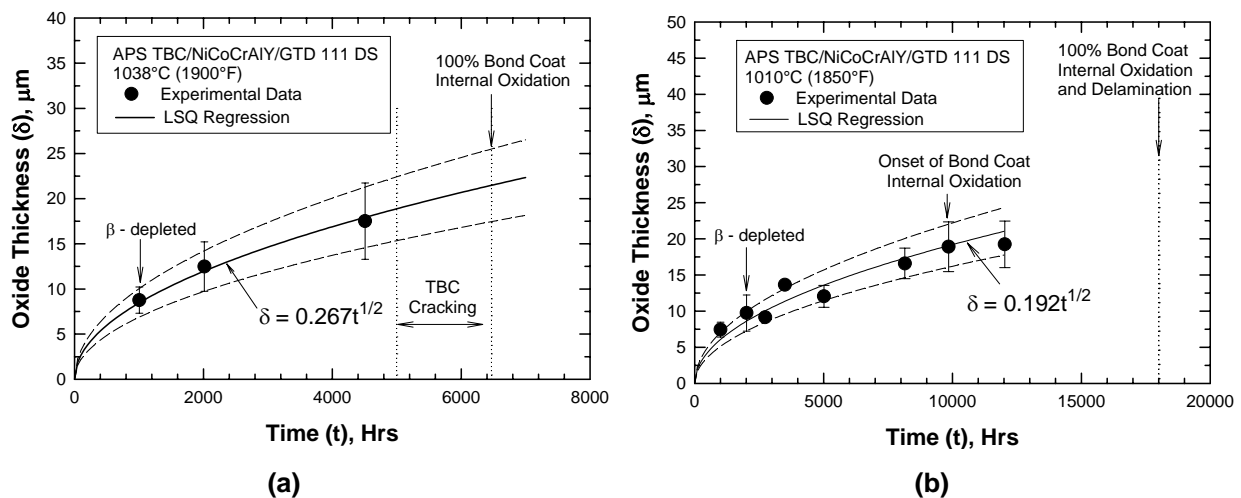
Figure 5-81
Determination of the critical oxide thickness at TBC cracking for APS TBC/ NiCoCrAlY/GTD-111DS: (a) TBC cracking was observed after 5000 hrs at 1900°F (1038°C), and (b) the onset of bond coat internal oxidation was observed after about 10,000 hrs at 1850°F (1010°C).

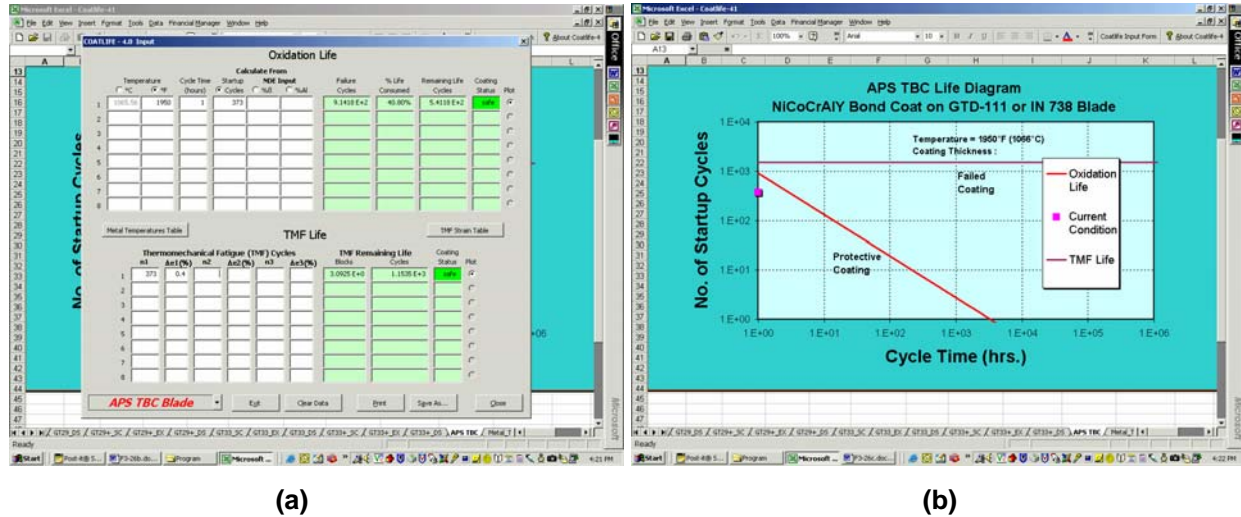
Figure 5-90
Verification of COATLIFE prediction against burner-rig tests: (a) COATLIFE prediction of a TBC life after 914 cycles, and (b) predicted coating life diagram for the APS TBC showing the TBC being protective after 373 one-hour thermal cycles.

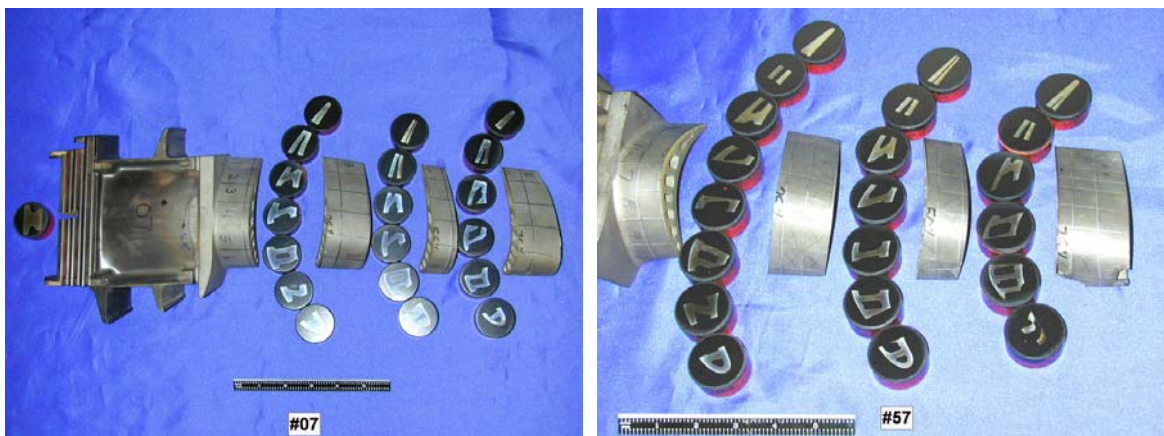
Figure 7-2
Photographs showing metallurgical sample locations in Blades 7 and 57.

on the blades. For NDE validation, three transverse sections at the 25%, 50%, and 75% blade height locations were removed from each blade. These locations correspond to transverse locations marked as A, C, and D on Blade 7, and B, E, and G on Blade 57. Each transverse section was cut into six or eight small sections. All of these small sections were mounted in a conductive mounting medium and polished using standard metallographic techniques. The locations of the mounts are illustrated in Figure 7-2. The mounts received from Blade C are shown in Figure 7-3. All of these metallurgical mounts were examined under optical and scanning electron microscopes to characterize the coating structure and to determine the chemical composition of the coating. The mounts prepared from Blades 7 and 57 were also examined for TMF cracking. The aluminum content in the coating at different locations was determined by performing EDS measurements.

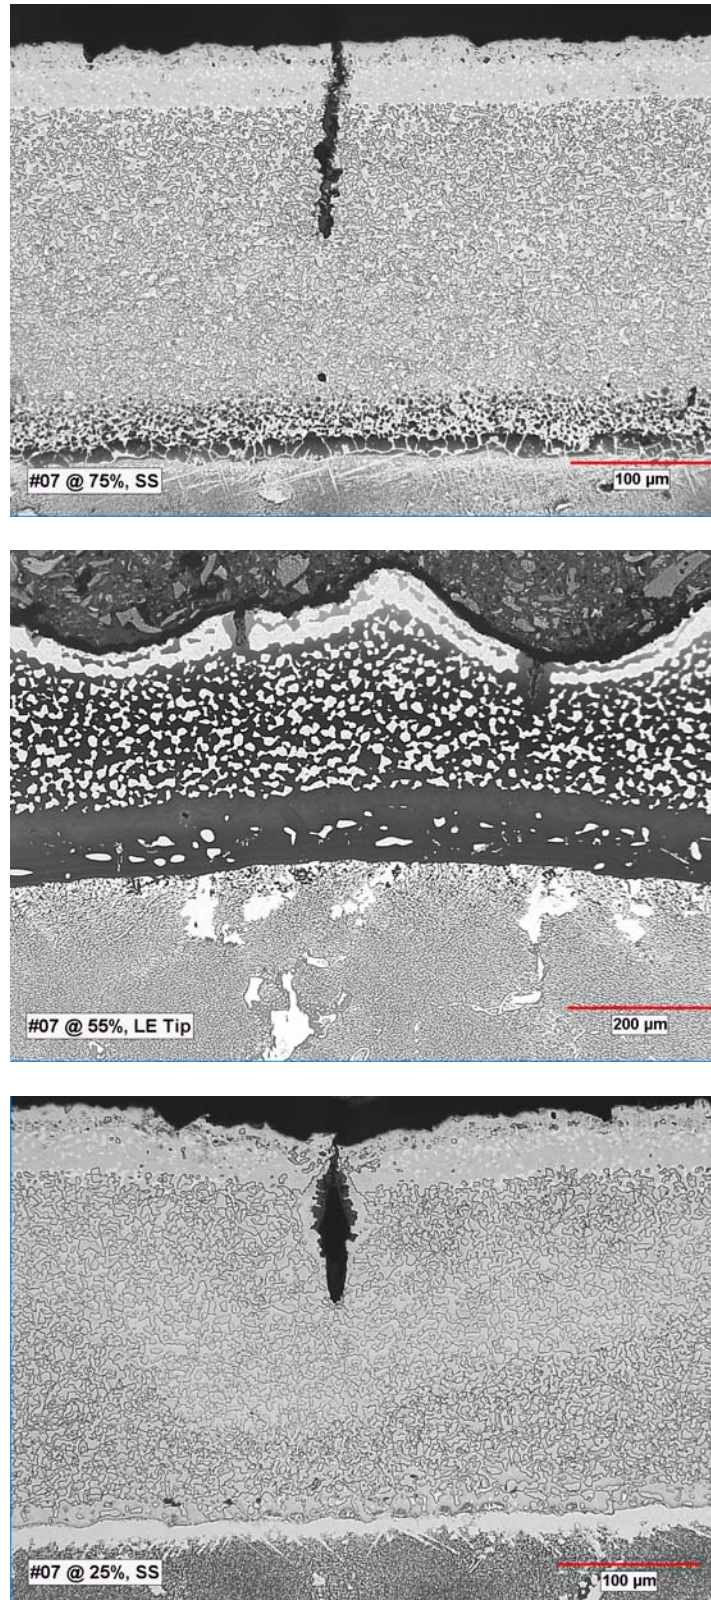
Figure 7-4
Optical micrographs of TMF cracks at different blade heights on Blade 7.

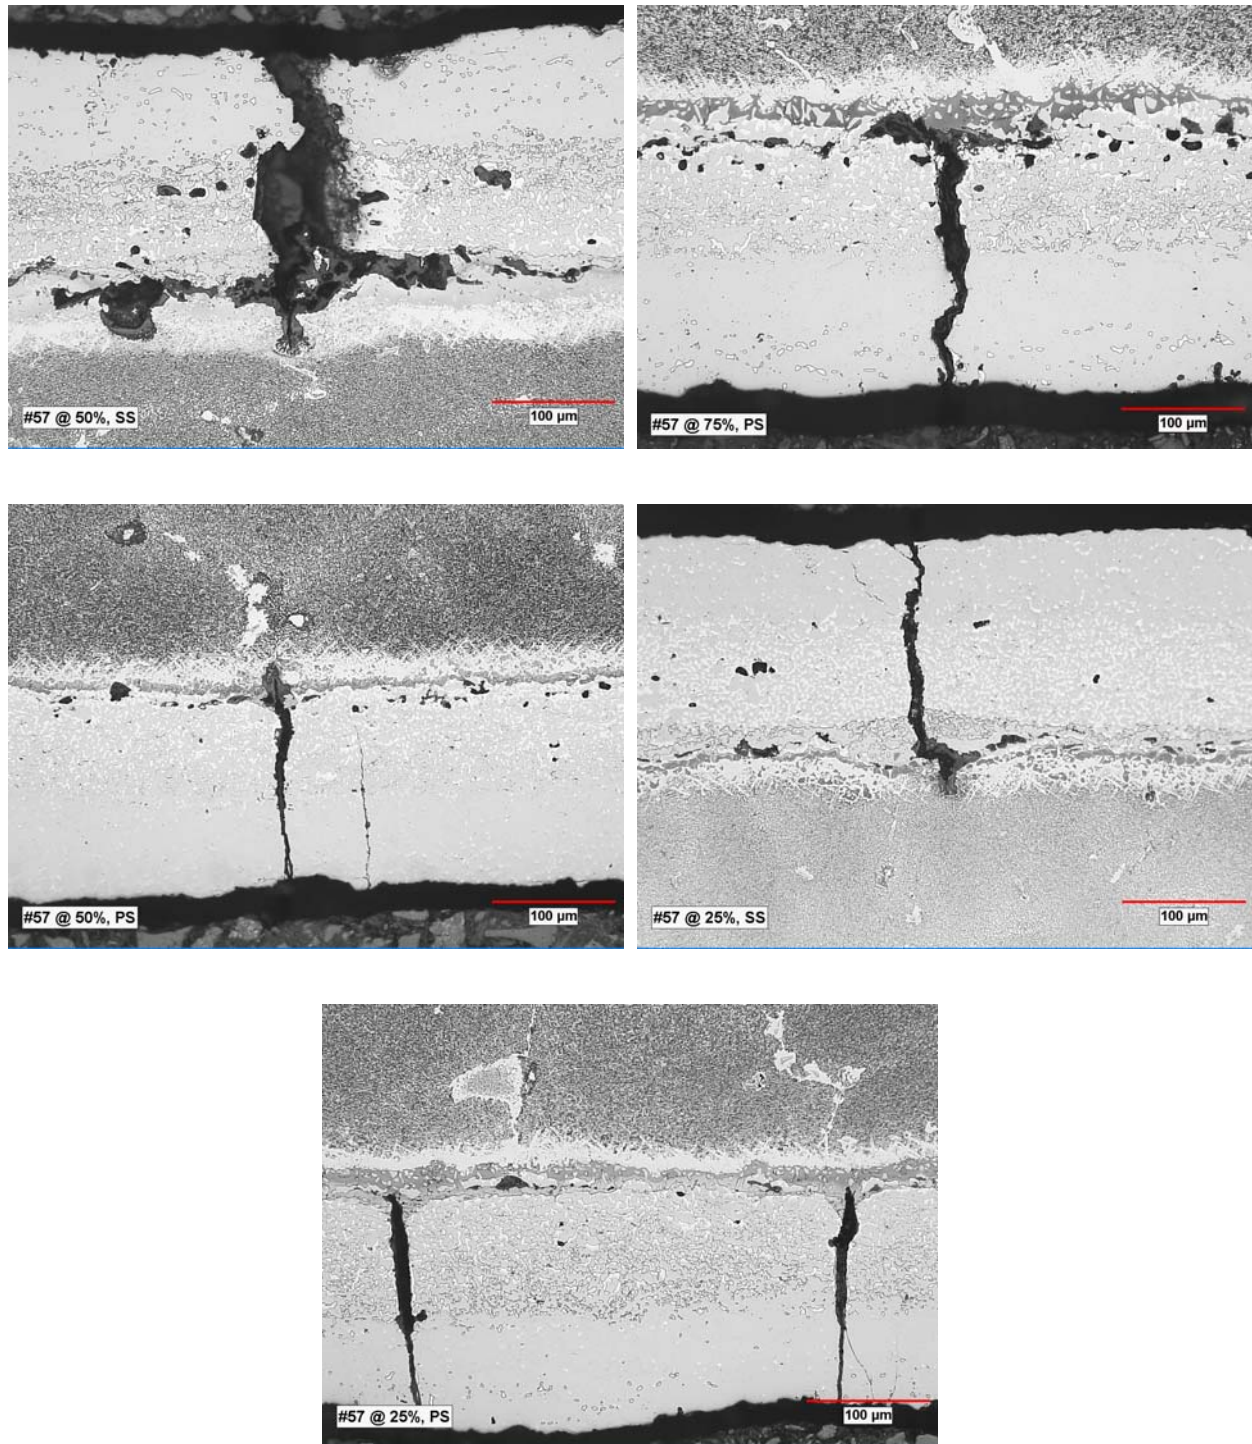
Figure 7-5
Optical micrographs of TMF cracks at different blade heights on Blade 57.

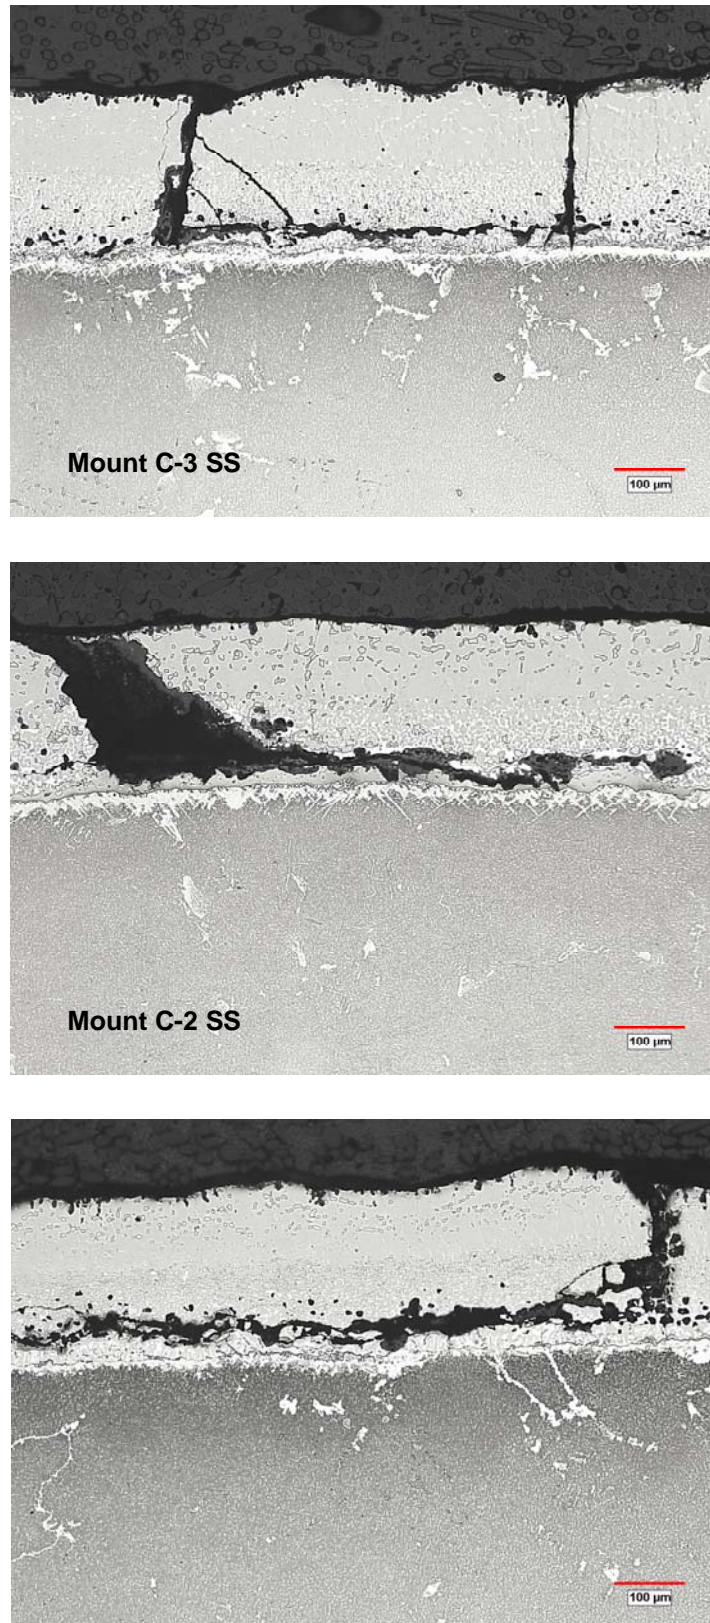
Figure 7-6
Optical micrographs of TMF cracks at 50% airfoil height of Blade C.

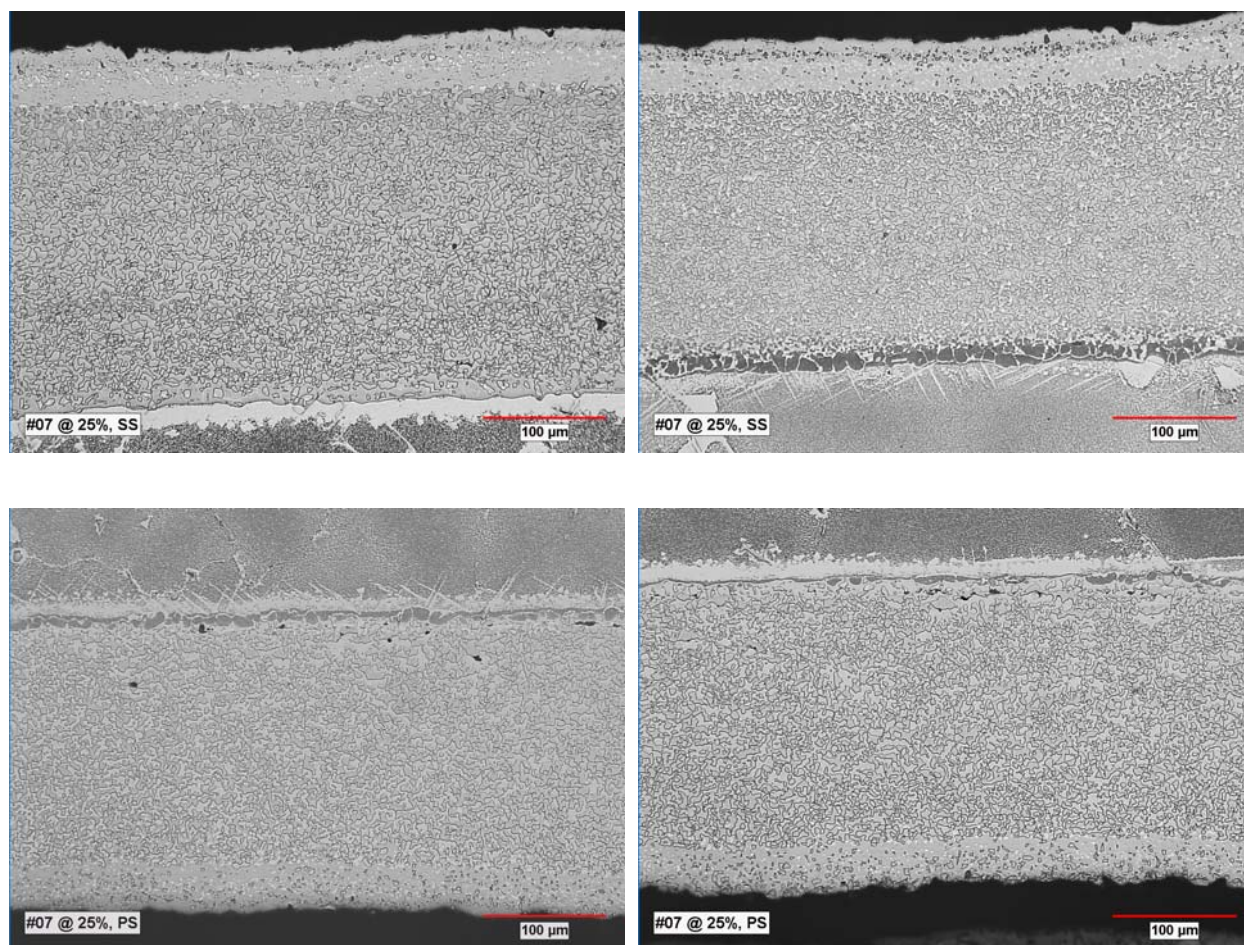
Figure 7-7
Typical microstructure of the coating at different locations on Blade 7.

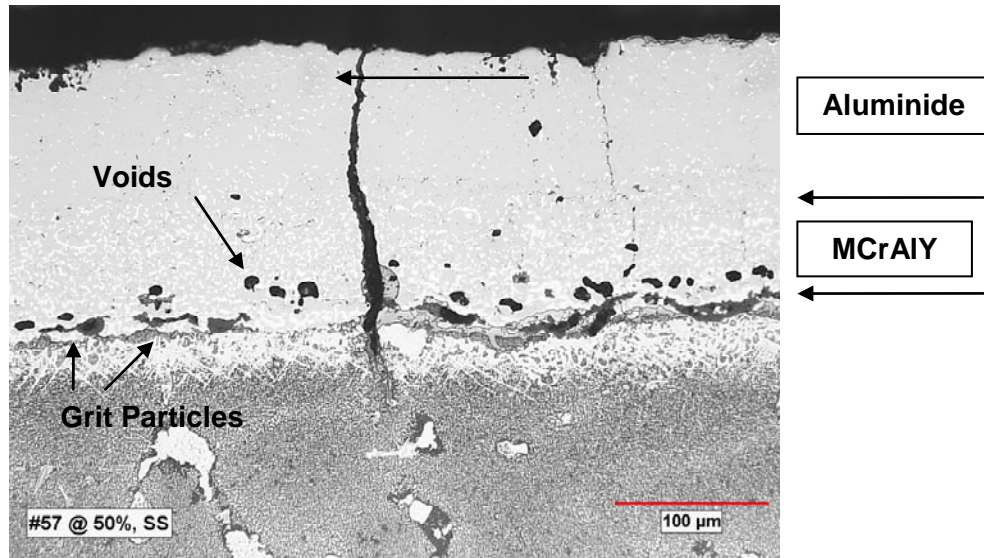
Figure 7-8
Optical micrographs of coating on Blade 57 showing the microstructure and coating thickness and the grit particles at the coating/substrate interface.

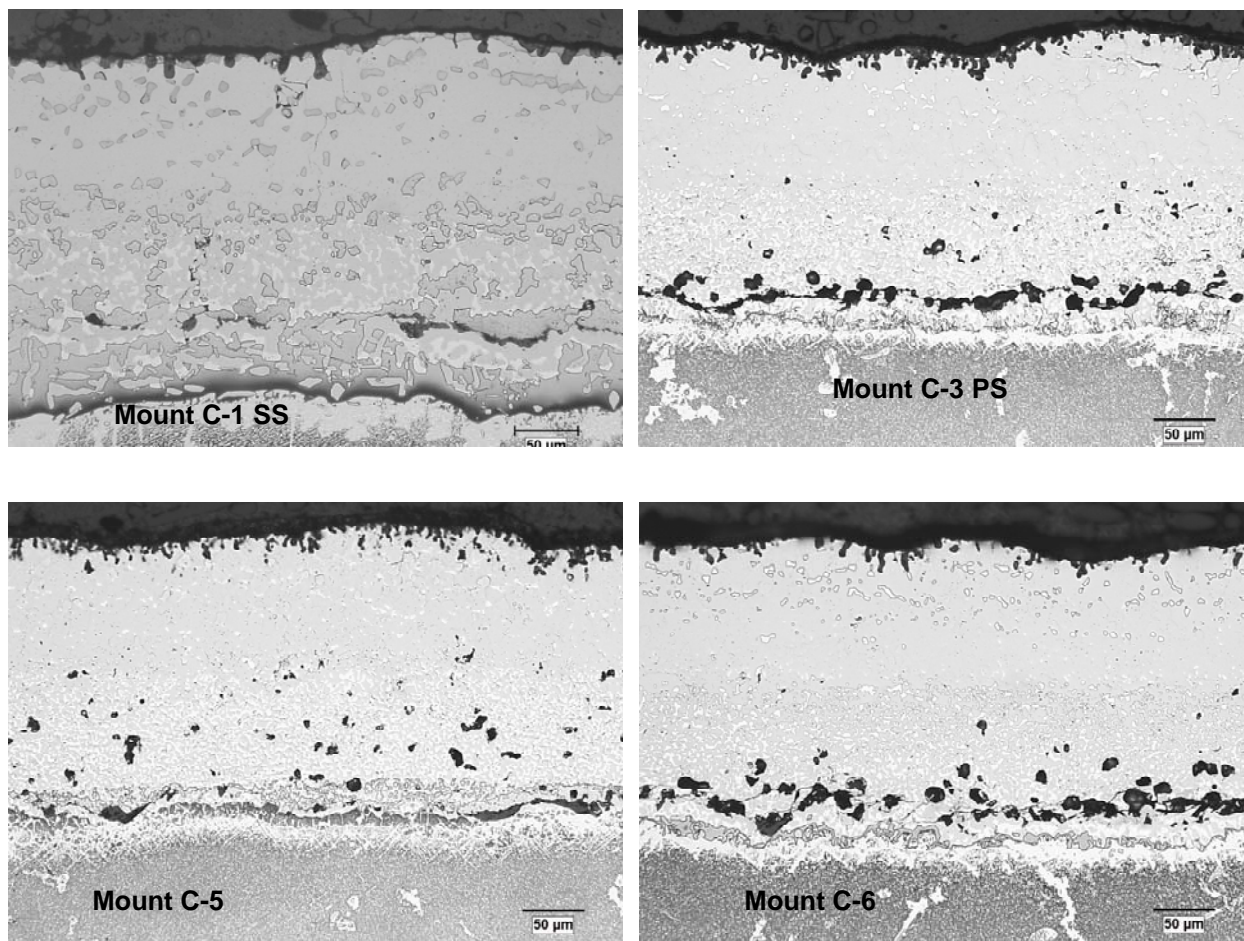
Figure 7-9
Optical micrographs of the coating on Blade C showing the microstructure and coating thickness and the grit particles at the coating/substrate interface.

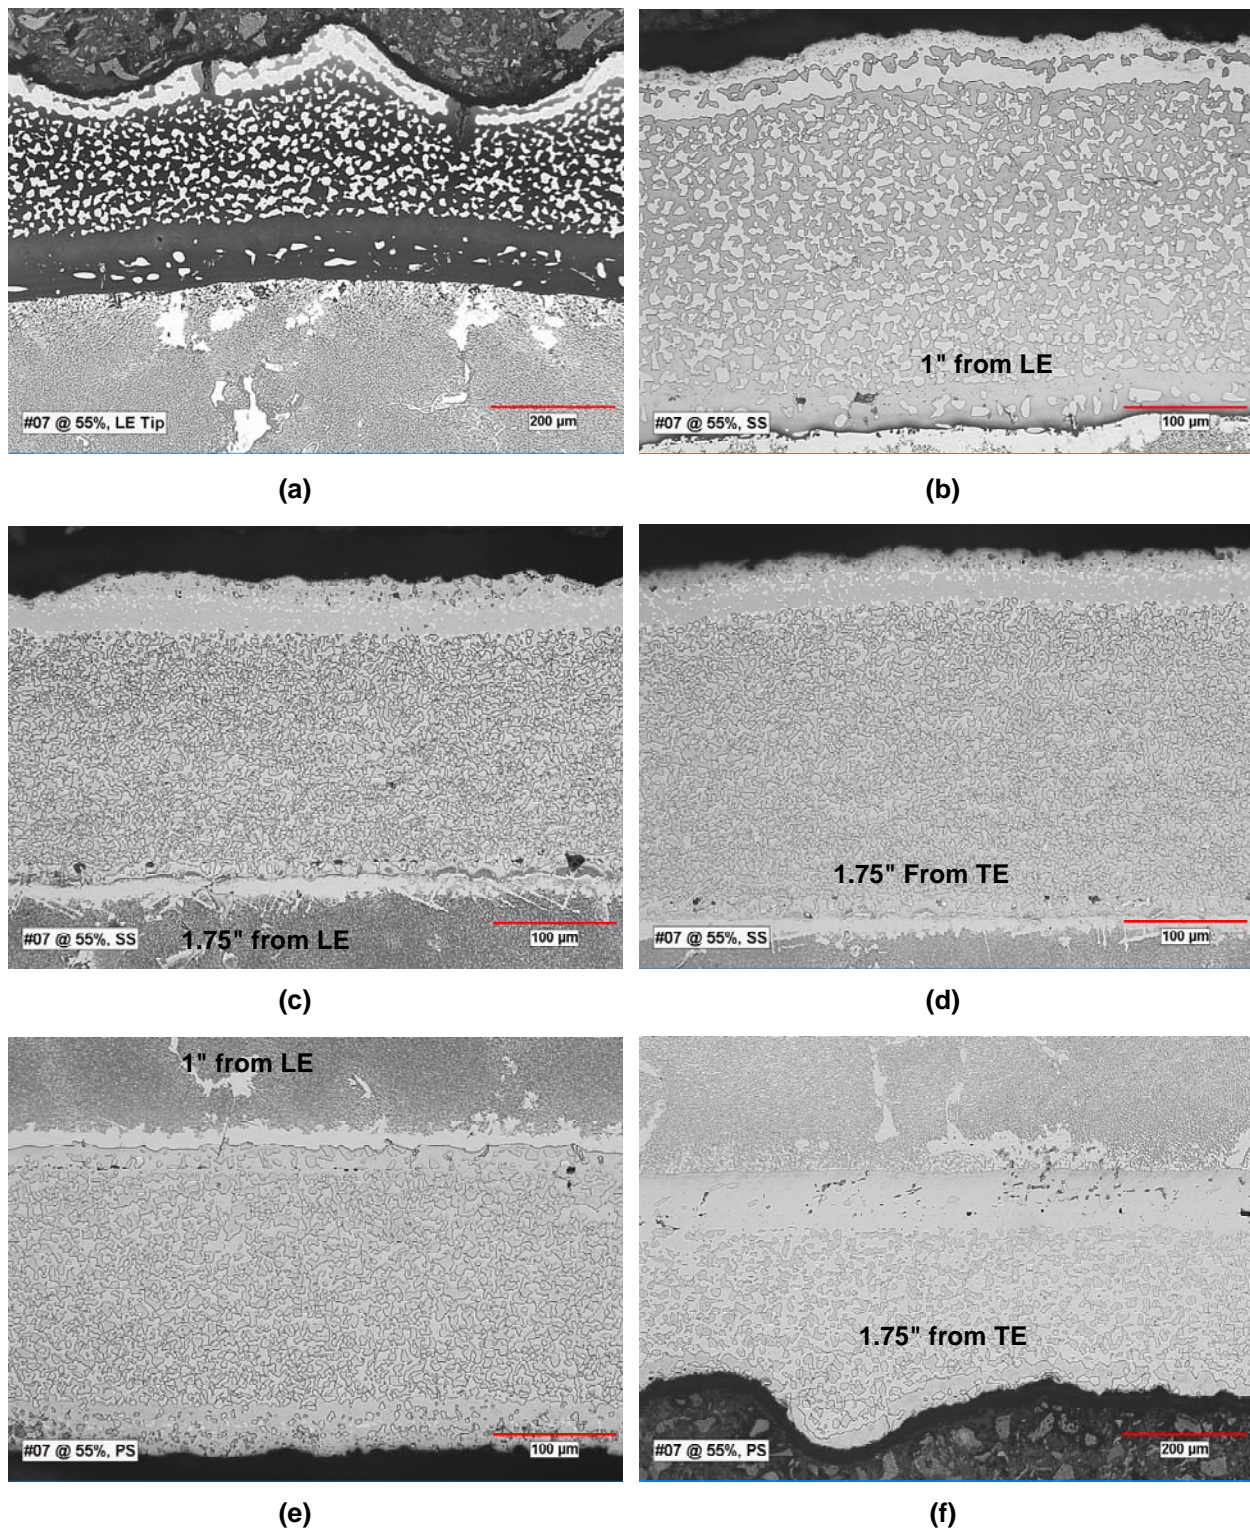
Figure 7-11
Optical micrographs showing the variation of coating degradation at the 50% airfoil height of Blade 7. Note the degradation of coating completely at the LE (a) and note that the coating showed no evidence of degradation on the suction side of the airfoil, 1.75 inches away from the trailing edge.

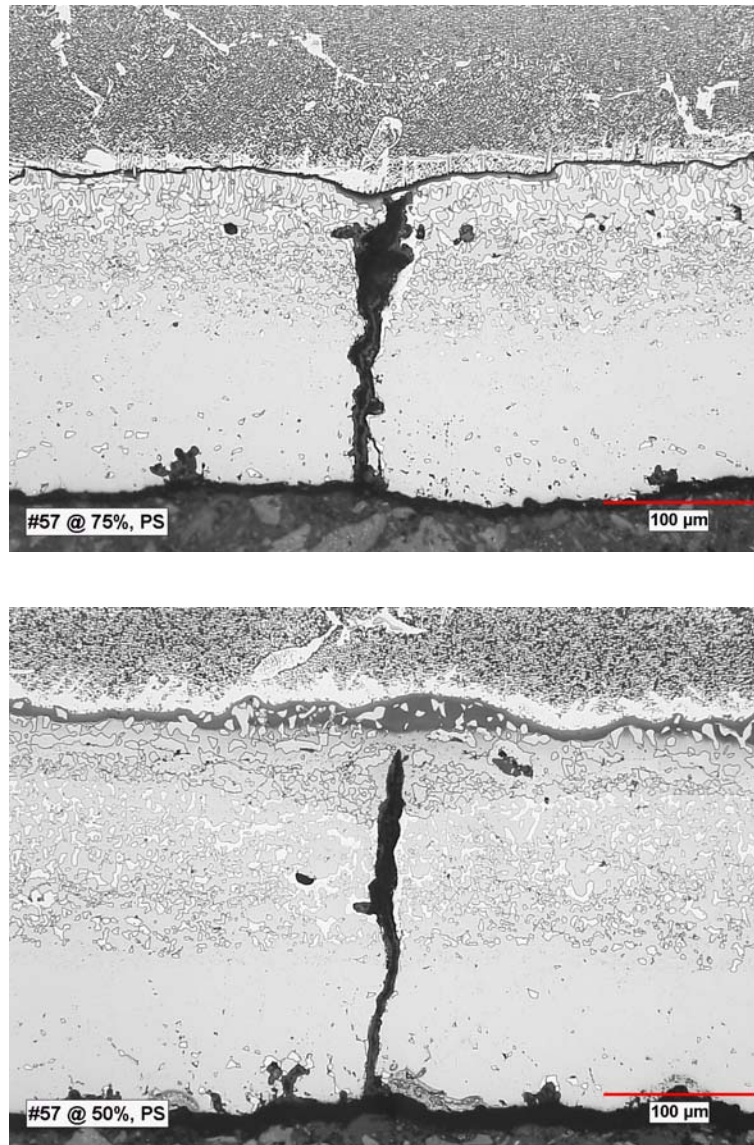
Figure 7-12
Microstructure of the coating on pressure side (PS) of the airfoil at the 75% and 50% blade heights.

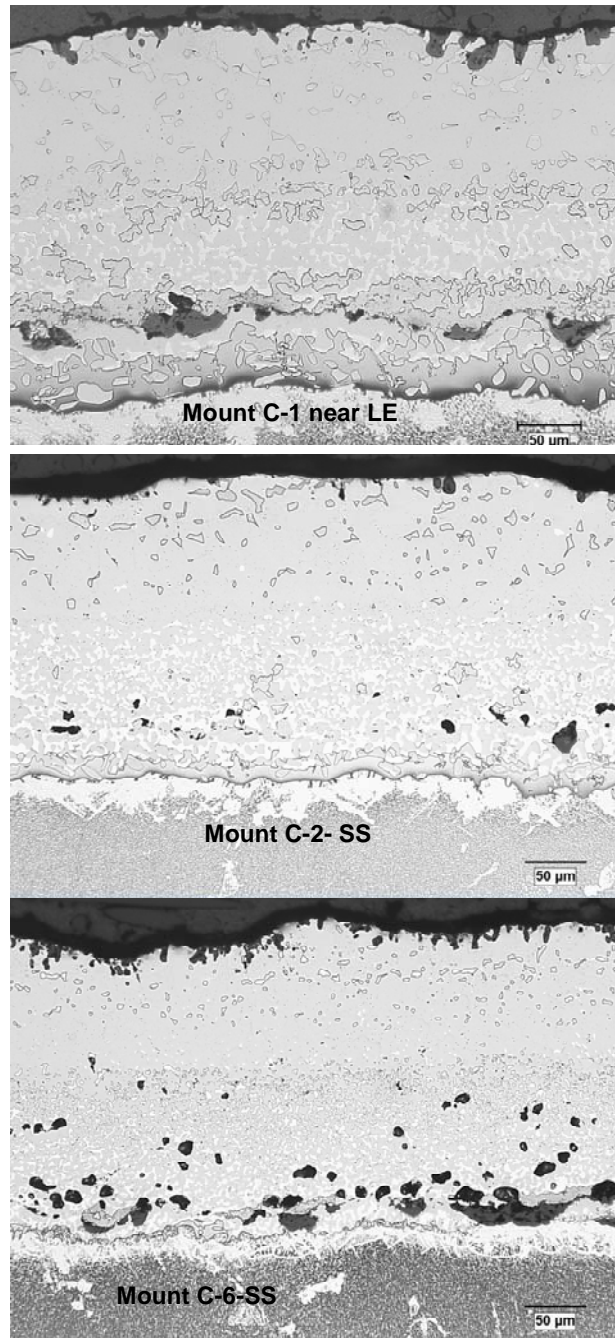
Figure 7-13
Microstructure of the coating on the suction side at the 50% airfoil height of Blade C.
